# Manhole Inspection Summary

Manhole # S19EE2006MH

**Location** Address: **1501 NEWBURY ST**

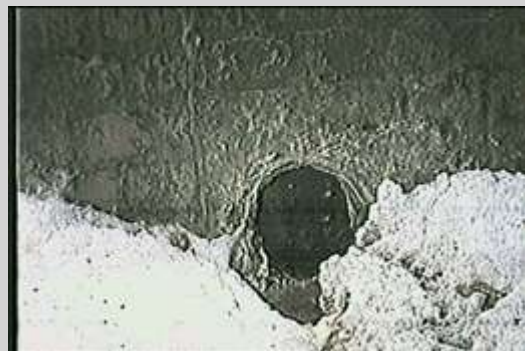
### Drop In @ 3 O'Clock

Drop: **Outside** Rod and Bar  
Angled: **Yes** Reading: **12.20** (ft.)  
Inv Depth: **13.20** (ft.)

Drop Condition: **Open**
